DEPARTMENT OF PLANNING & SUSTAINABILITY

Land Development Environmental Inspection Report				
Inspector Name: A. McDyess/E. Emmett/D. Pearson	Date: 4/4/2023			
Owner/Tenant/Contractor: Alan Williams	Phone: 770-354-3392			
Address of Subject Property: 561 Key Rd / 1350 Constitution	District/Zone: 15 081 08 001			
Permit No.: 1245564	NPDES Tracking No. N/A			
 <u>Site Visit Purpose:</u> Follow-up site inspection after the Zoom appointment	Compliance/Violation Determination: -BMPs compliance obtained -Silt Fence in the GA Power Easement Area that the protesters damaged/destroyed has been corrected No sediment escape or environmental impacts observedRepairs to all the silt fence and tree protection has been made, the site is in compliance and is environmentally up to DeKalb County Ordinance.			
Notice of violations Issued? No, construction violations were observed.	Stop Work Order issued? Yes No			
Follow up action: TBD	Re-inspection date: TBD

Re: 1350 Constitution/561 Key

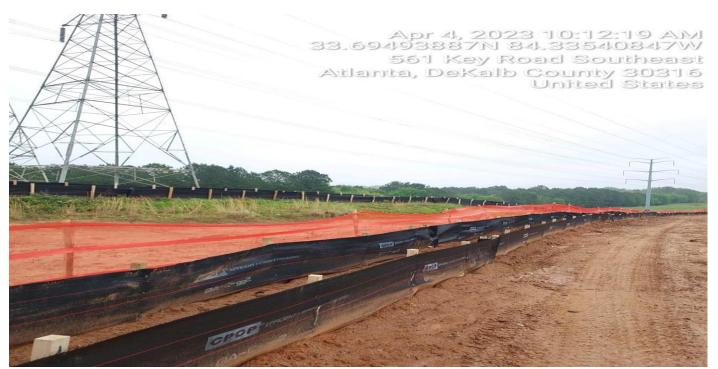
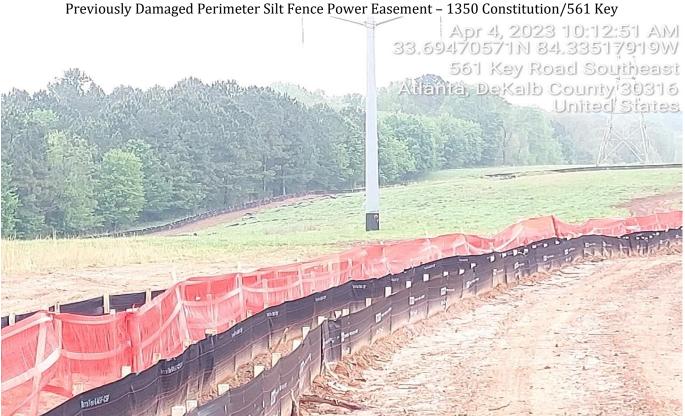
Previously Destroyed Perimeter Silt Fence at Power Easement Area

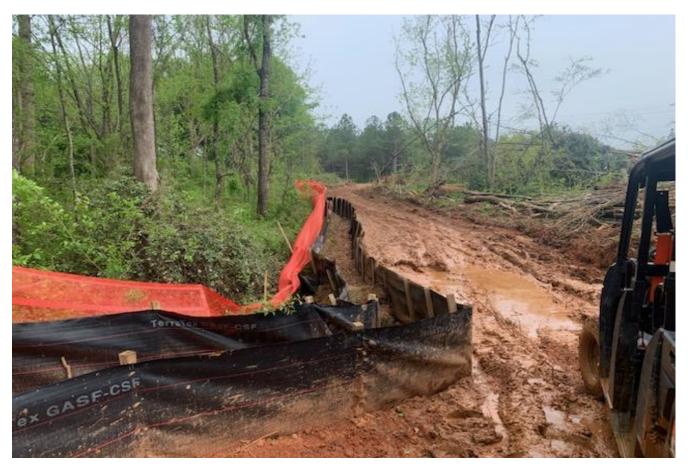
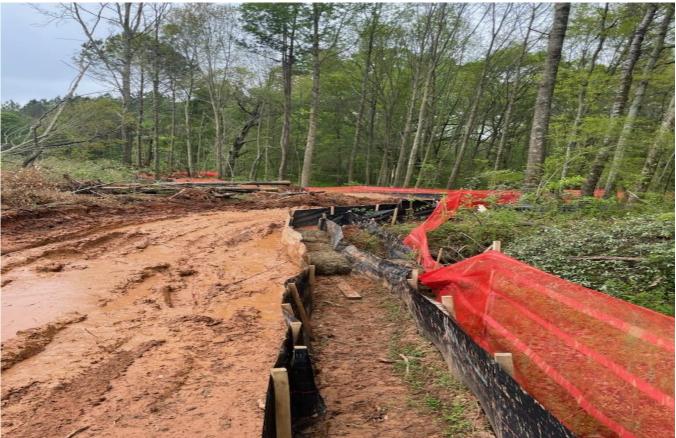
Silt fence repaired where fallen tree damage took place; Hay bales and an extra row of silt fence was added for additional stabilization
